Targeted Brownfields Assessment Phase II Environmental Site Assessment

Former Georgetown Police Department and Call Center
Department of Environmental Protection Agency Interest #79227
Scott County
Georgetown, KY

Kentucky Division of Waste Management 14 Reilly Road Frankfort, KY 40601

June 2008

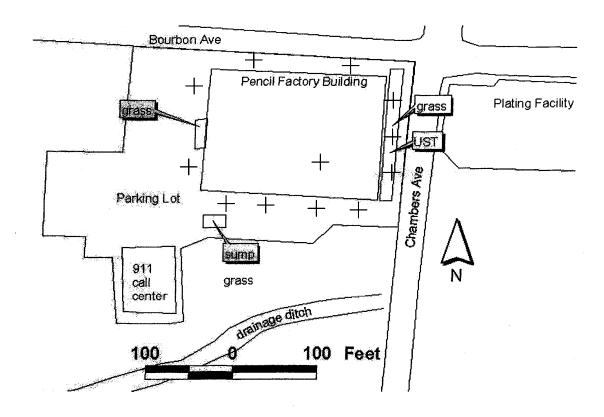
Map 2. Major features of the Georgetown Police Station. Soil Borings symbolized by +.

Field exploration consisted of advancing borings to the soil/bedrock interface in various areas outside the building and to one meter below the underground storage tank. Soil samples were submitted to the lab for analysis. Moreover, soil from the artificial fill under the building was sampled in the soil exposed in the crawlspace illustrated in Figure 18. No groundwater was encountered during the course of the investigation. Various containers that were left on site were catalogued by an independent contractor and removed to a hazardous waste landfill.
